THE RADIOLOGICAL ACCIDENT IN SAN SALVADOR

A REPORT PREPARED BY THE
INTERNATIONAL ATOMIC ENERGY AGENCY
IN CO-OPERATION WITH THE
PAN AMERICAN HEALTH ORGANIZATION OF THE
WORLD HEALTH ORGANIZATION

INTERNATIONAL ATOMIC ENERGY AGENCY
VIENNA, 1990

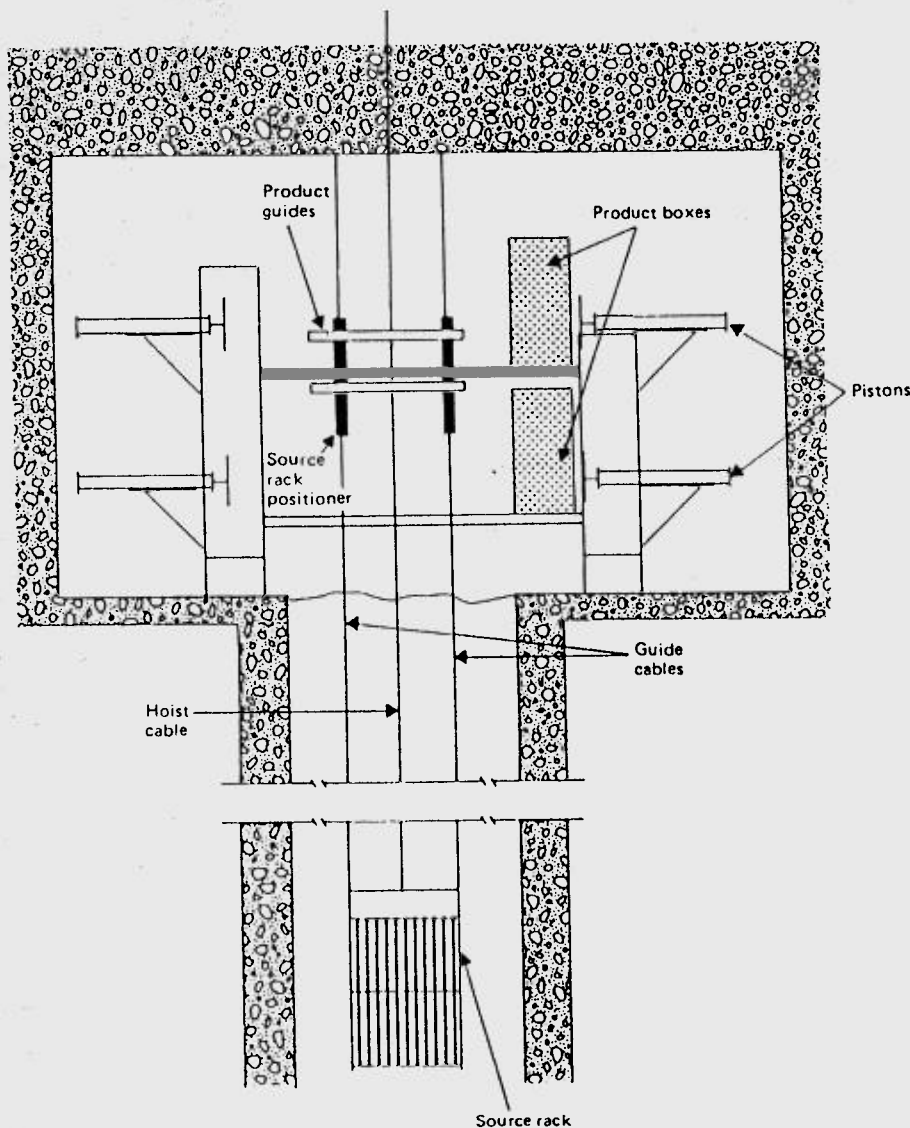
FIG. 6. Cross-sectional diagram of the source rack, hoist mechanism and transport mechanism. (By courtesy of Nordion International Inc.)

Earlier in the shift, when repairing one of the pistons for this second row, he had found that two boxes had cracks, but since they could still hold the products he had not removed them. These deformed boxes may subsequently have disrupted the system for detecting the positions of the boxes, causing the five boxes to be squeezed into the space for four. The deformation of these boxes probably buckled the metal product guides on the conveyor (see Fig. 6), preventing the source rack from being lowered.

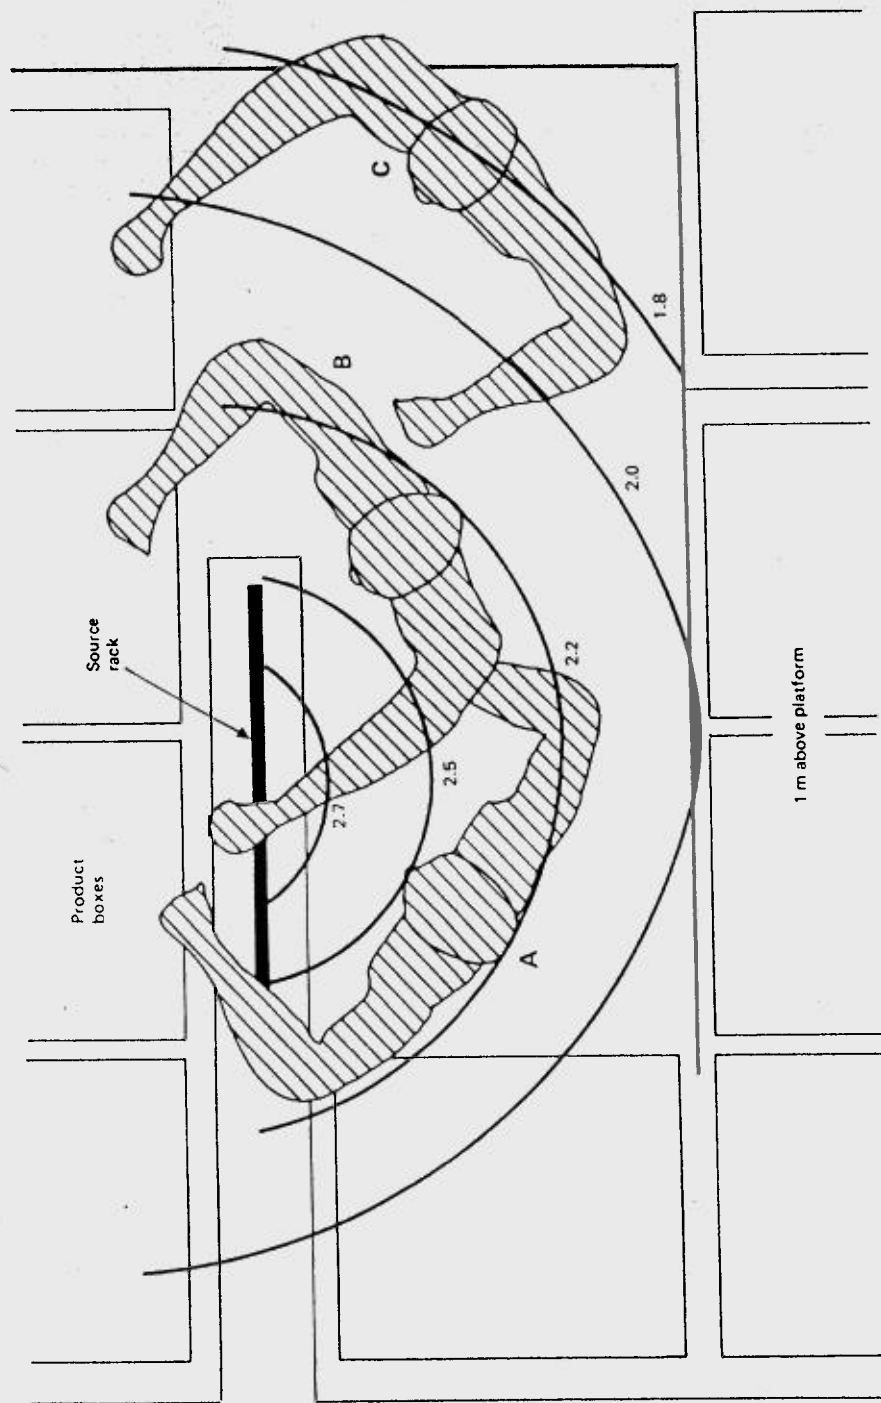
FIG. 13. Plan view of the positions in relation to the source rack of Workers A, B and C during the accident with dose rate contours in $\text{Gy} \cdot \text{min}^{-1}$. (Source: REAC/TS.)

The next phase of the accident was probably when the three workers sustained the largest share of their doses. They would have been moving, but the positions and dose rate contours shown in Figs 13-15 can be taken as indicative of the patterns of exposure. In order to free the source rack they first had to raise it (a mass of about 60 kg) by all three pulling on the hoist cable. Eventually the three men were standing broadly in line on the upper level (Fig. 16). Worker A was in a crouching position with his legs slightly apart and his right leg forward directly in front of the rack. To his right, Worker B had his left leg nearer the source. (The leading leg of each man

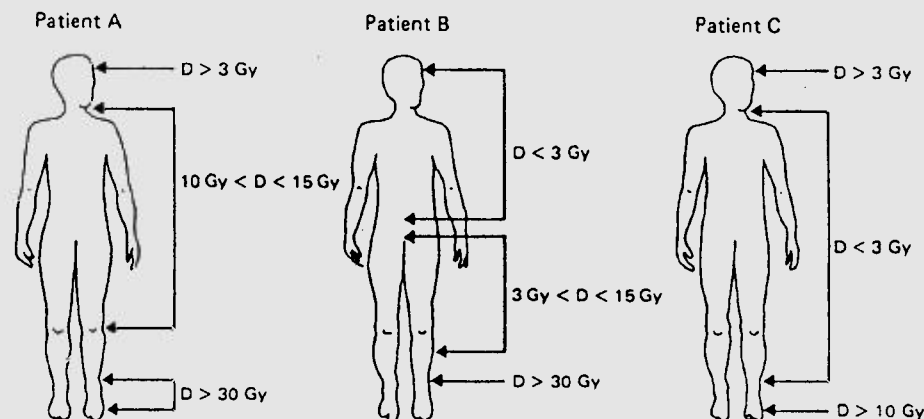
FIG. 17. Patients A, B and C: doses D incurred by different parts of the body. (Source: REAC/TS.)

From Day 32 to Day 36 (Wednesday 8 to Saturday 12 March) the medical team at the Angeles del Pedregal Hospital in Mexico City worked together with the IAEA expert team from REAC/TS to assist in both medical and dosimetric aspects. Assessments of the patients' dose distributions were made on the bases of the onset and extent of epilation and dry and wet desquamation and early signs of necrotic lesions. These assessments, which did not substantially change afterwards, are presented in Fig. 17.

Patient A: 8.1 Gy
Patient B: 3.7 Gy
Patient C: 2.9 Gy.
