THE RADIOLOGICAL ACCIDENT IN SAN SALVADOR

A REPORT PREPARED BY THE
INTERNATIONAL ATOMIC ENERGY AGENCY
IN CO-OPERATION WITH THE
PAN AMERICAN HEALTH ORGANIZATION OF THE
WORLD HEALTH ORGANIZATION

INTERNATIONAL ATOMIC ENERGY AGENCY
VIENNA, 1990

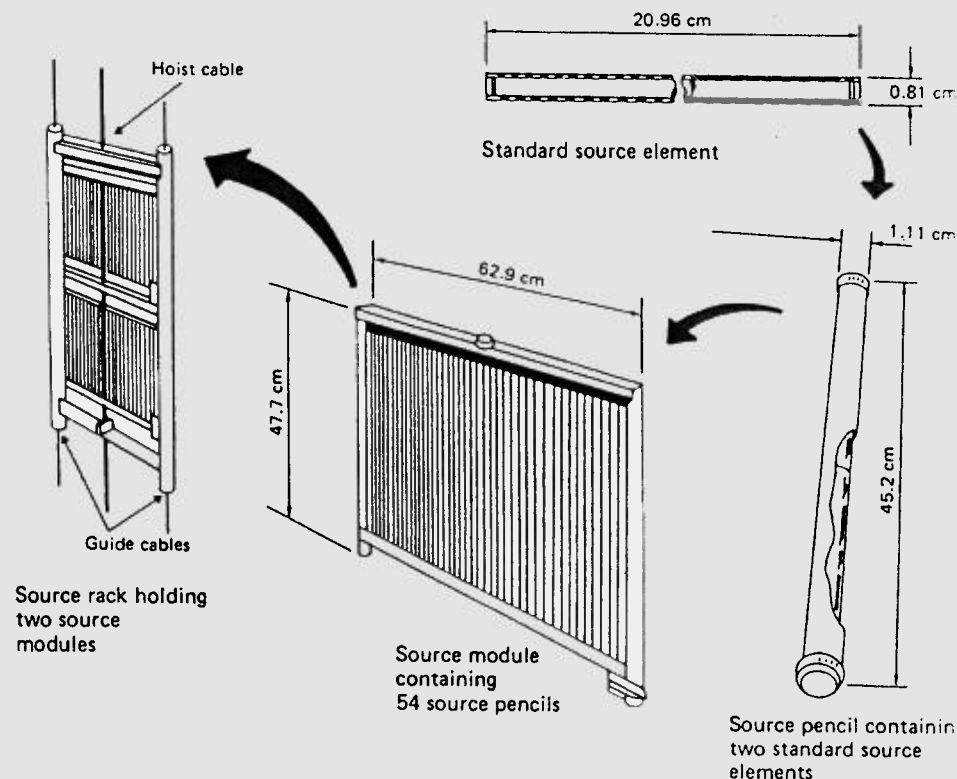
FIG. 5. The source rack with two source modules, each containing up to 54 source pencils with two standard source elements in each pencil. (By courtesy of Nordion International Inc.)

Working by torchlight, Worker A removed two of the five boxes, one of which was wedged against the lower of the two source modules in the source rack (see Fig. 5). This took several minutes. The left side of the source rack then became visible. He noticed that the slack cable that he had paid through from the roof was draped over the fixed product guide just above the upper floor level and was obstructing the descent of the source rack.

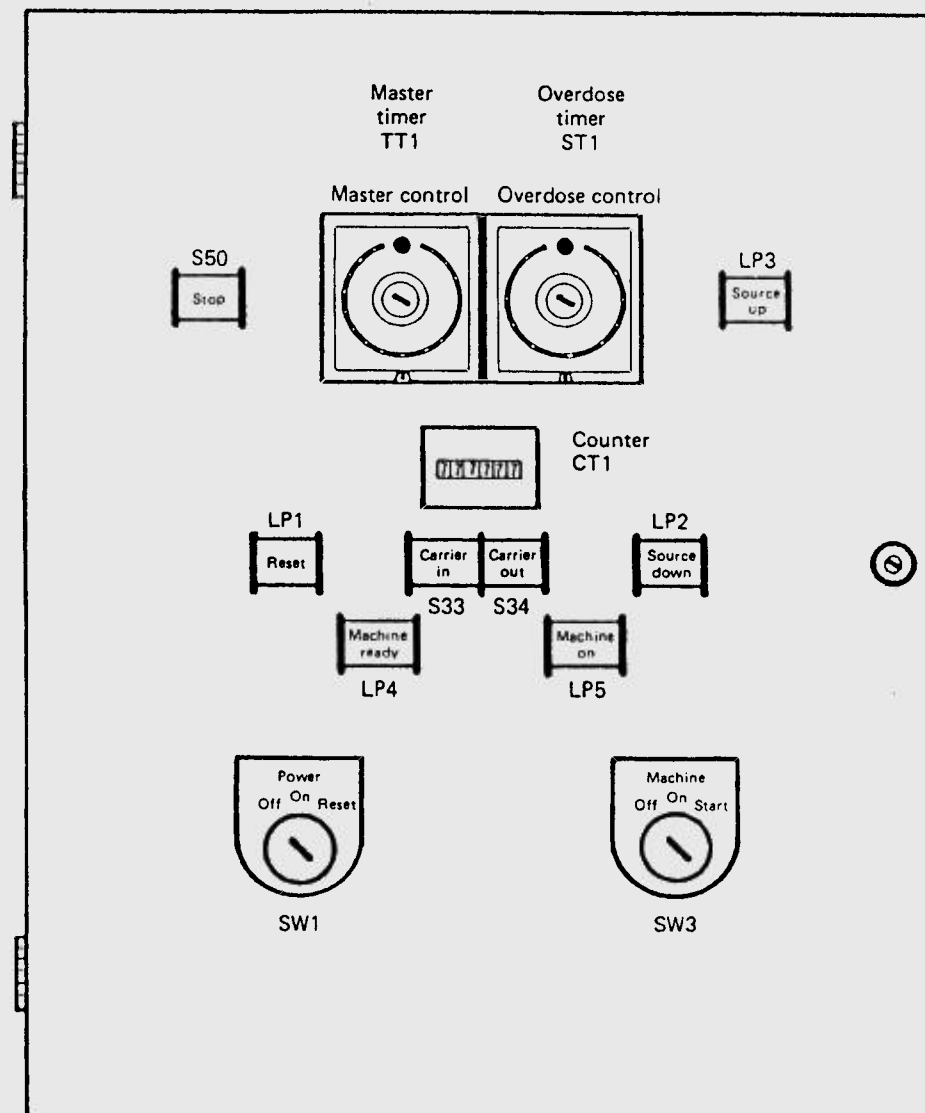
FIG. 9. The control panel of the JS6300 irradiator. (By courtesy of Nordion International Inc.)

Although Fig. 9 shows the panel as having illuminated legends, at the time of the accident the panel had no markings to indicate the significance of the controls or the warning lights. (However, the workers interviewed who were responsible for operating the controls were familiar with their functions.) In addition, a skylight above made it difficult to see whether the warning lights were on in the daytime.

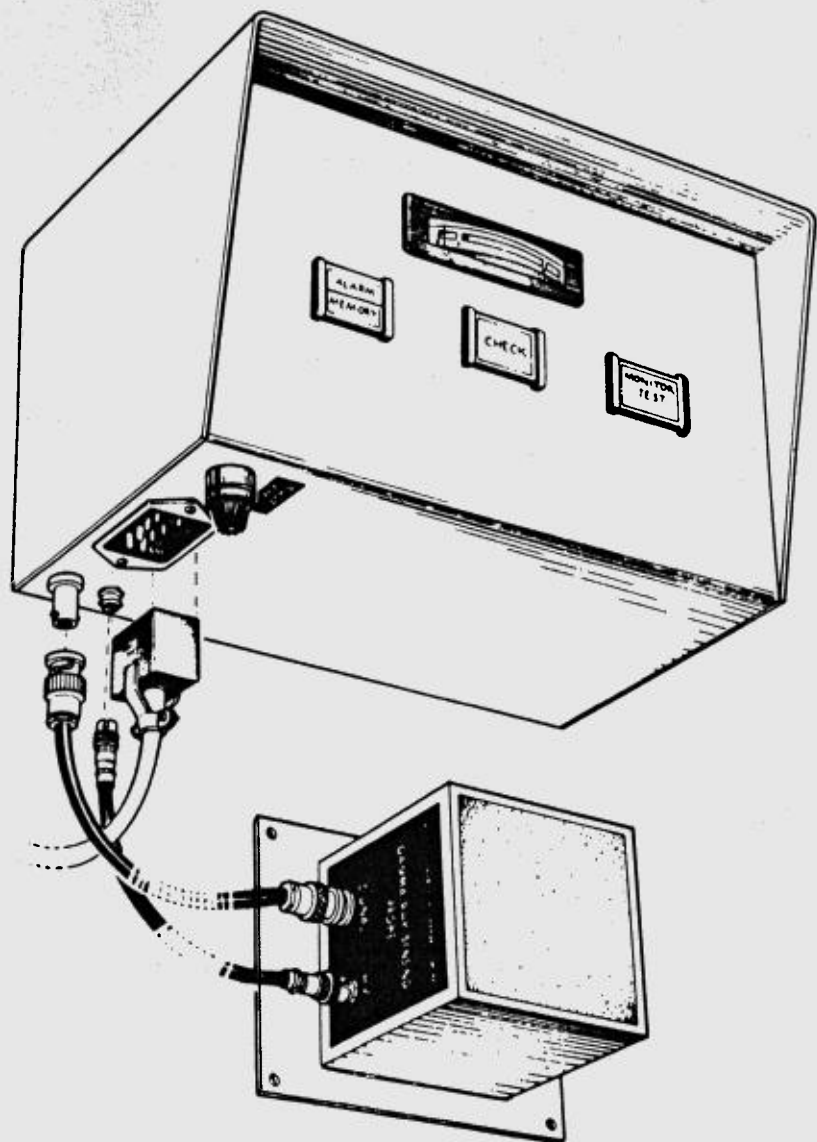
FIG. 10. The L118 wall mounted single probe monitor system. (By courtesy of Nordion International Inc.)

More than five years before the accident, the monitor probe had failed and the probe assembly had been removed. Its cabling remained. Removal of the monitor probe should have disabled the irradiator. However, it was discovered that access could be gained to the radiation room by depressing the monitor test switch and repeatedly cycling the buttons on the panel of the radiation monitor. This method of gaining access became the 'usual' procedure. The access door had not been maintained and had become badly fitting, with the result that it could also be opened by force or by using the blade of a knife to slip the catch (see Photographs 5 and 6). Thus one major safety feature of the design was bypassed.

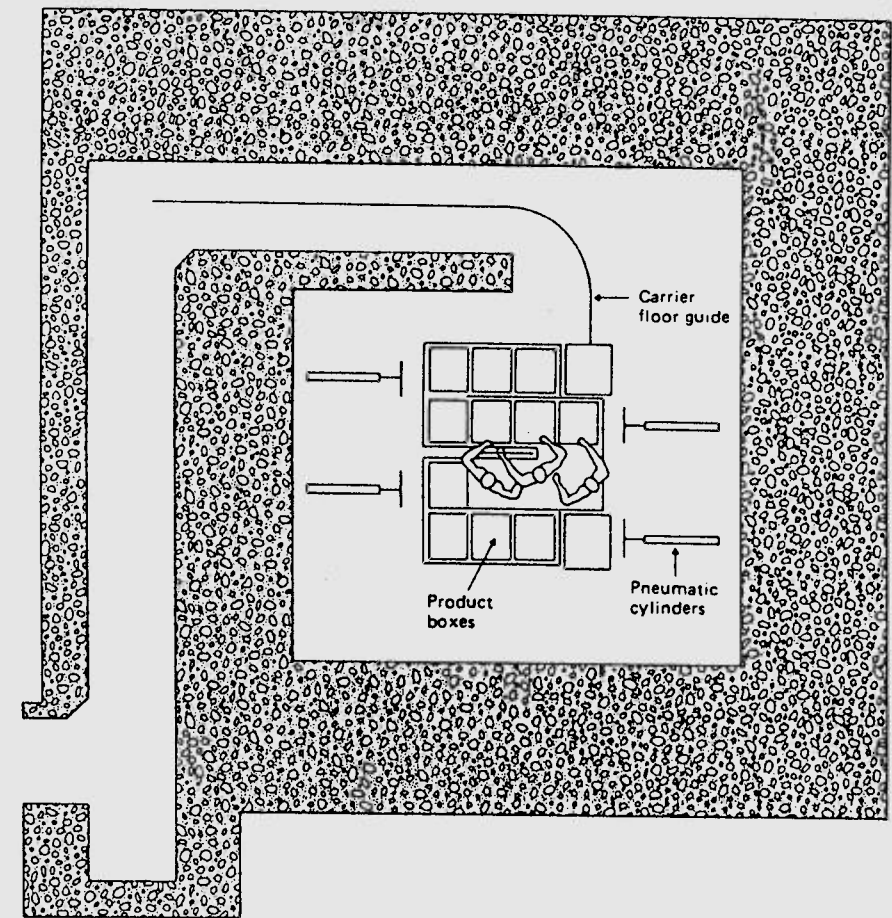
FIG. 12. Plan view of the positions of Workers A, B and C in the radiation room during the accident. (Source: REAC/TS.)

Shortly afterwards, at about 03:00, Worker A returned with Workers B and C, from another department, who had no experience of the irradiation facility. On being asked about any hazard, Worker A assured the others that there was no danger since the machine was switched off. The three men entered the radiation room and proceeded to remove product boxes from the third row on the upper level (adjacent to the source) so that the source rack could be freed from above (see Figs 12 and 13).

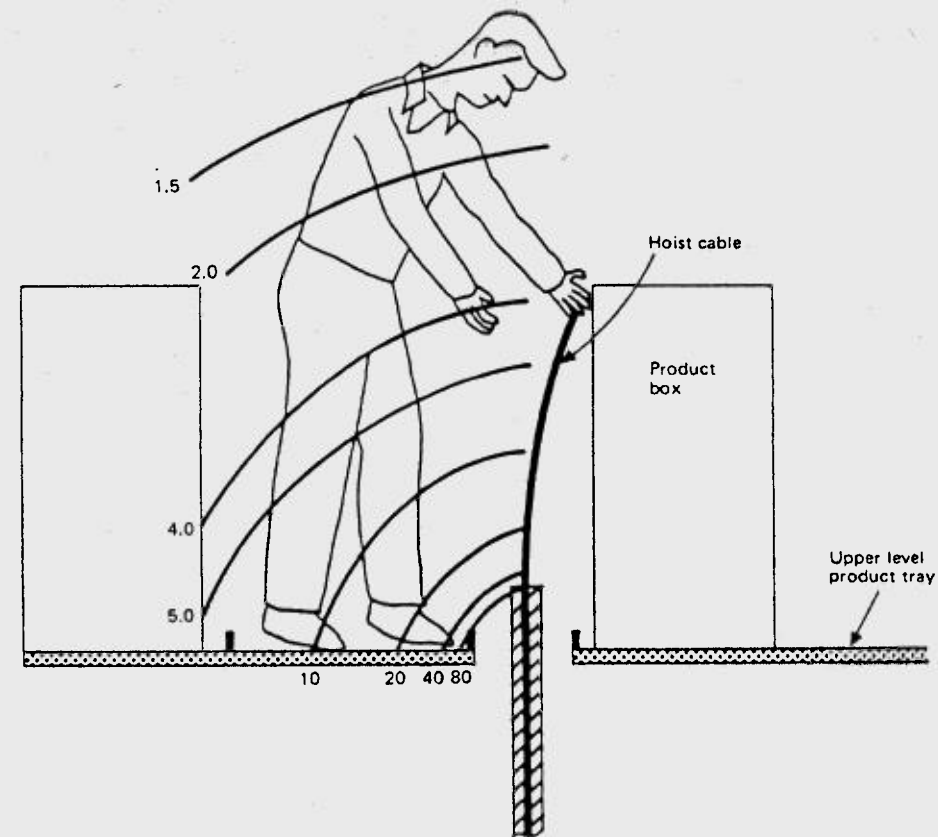
FIG. 14. Dose rate contours for a standing figure: rates in $\text{Gy} \cdot \text{min}^{-1}$. (Source: REAC/TS.)

The next phase of the accident was probably when the three workers sustained the largest share of their doses. They would have been moving, but the positions and dose rate contours shown in Figs 13-15 can be taken as indicative of the patterns of exposure. In order to free the source rack they first had to raise it (a mass of about 60 kg) by all three pulling on the hoist cable. Eventually the three men were standing broadly in line on the upper level (Fig. 16). Worker A was in a crouching position with his legs slightly apart and his right leg forward directly in front of the rack. To his right, Worker B had his left leg nearer the source. (The leading leg of each man
